The Battleship Action 14-15 November 1942

By Robert Lundgren

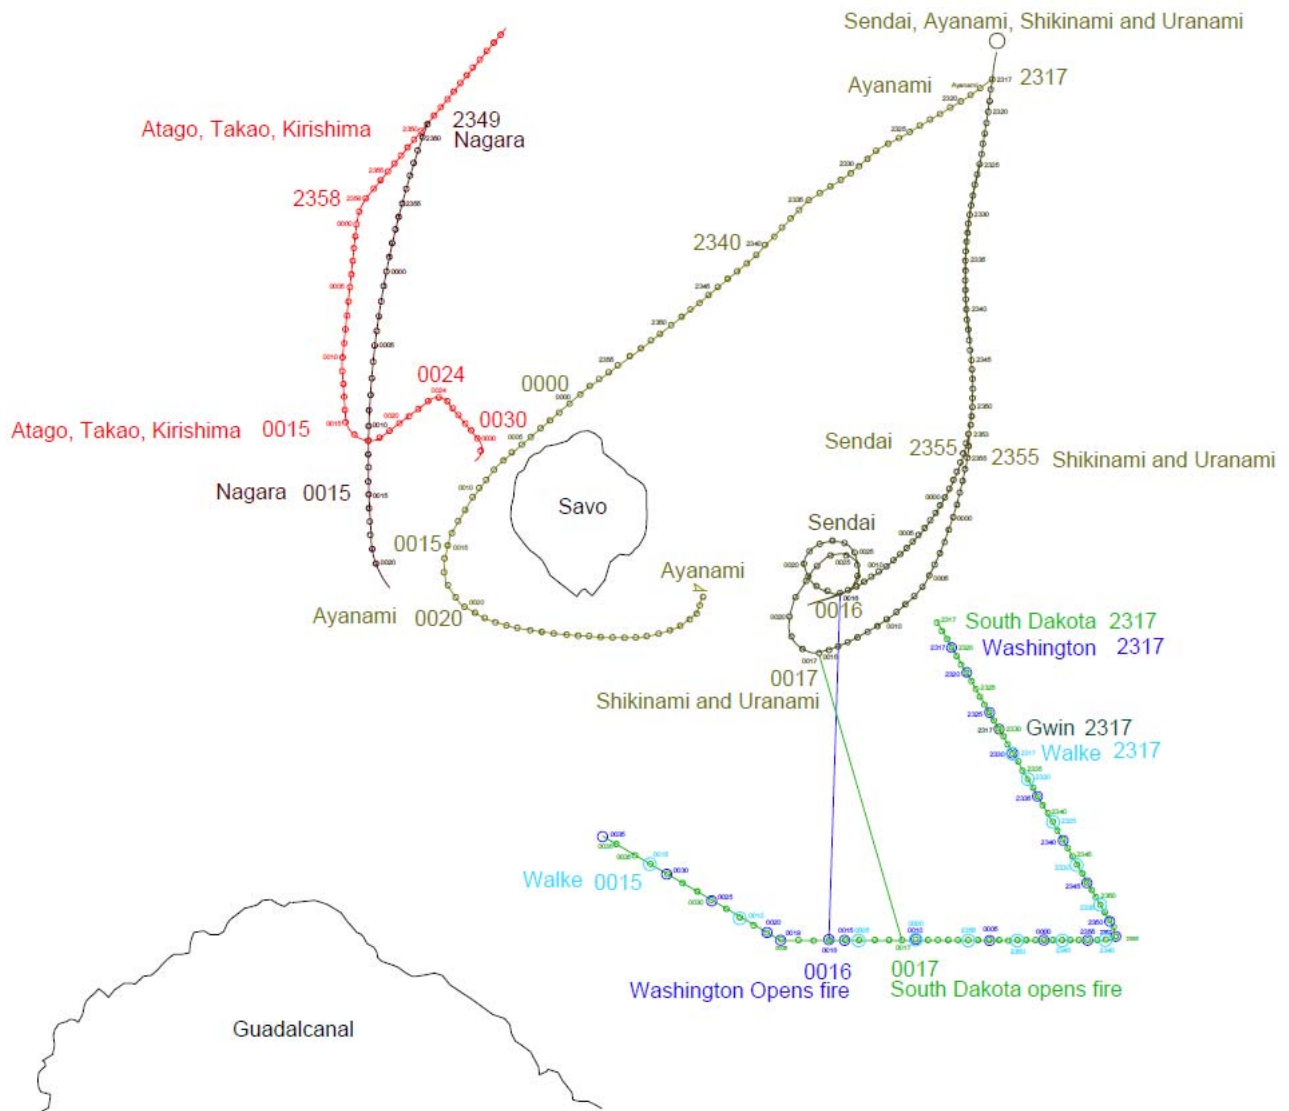
Opening Phase from 2317 to 0020
Figure 1

In the track charts *Atago, Takao, and Kirishima* are in red, *Nagara* is brown, *Sendai* and *Ayanami* are in yellow, *South Dakota* is green, *Washington* is dark blue, *Walke* is light blue, other US destroyers are represented by turquoise.

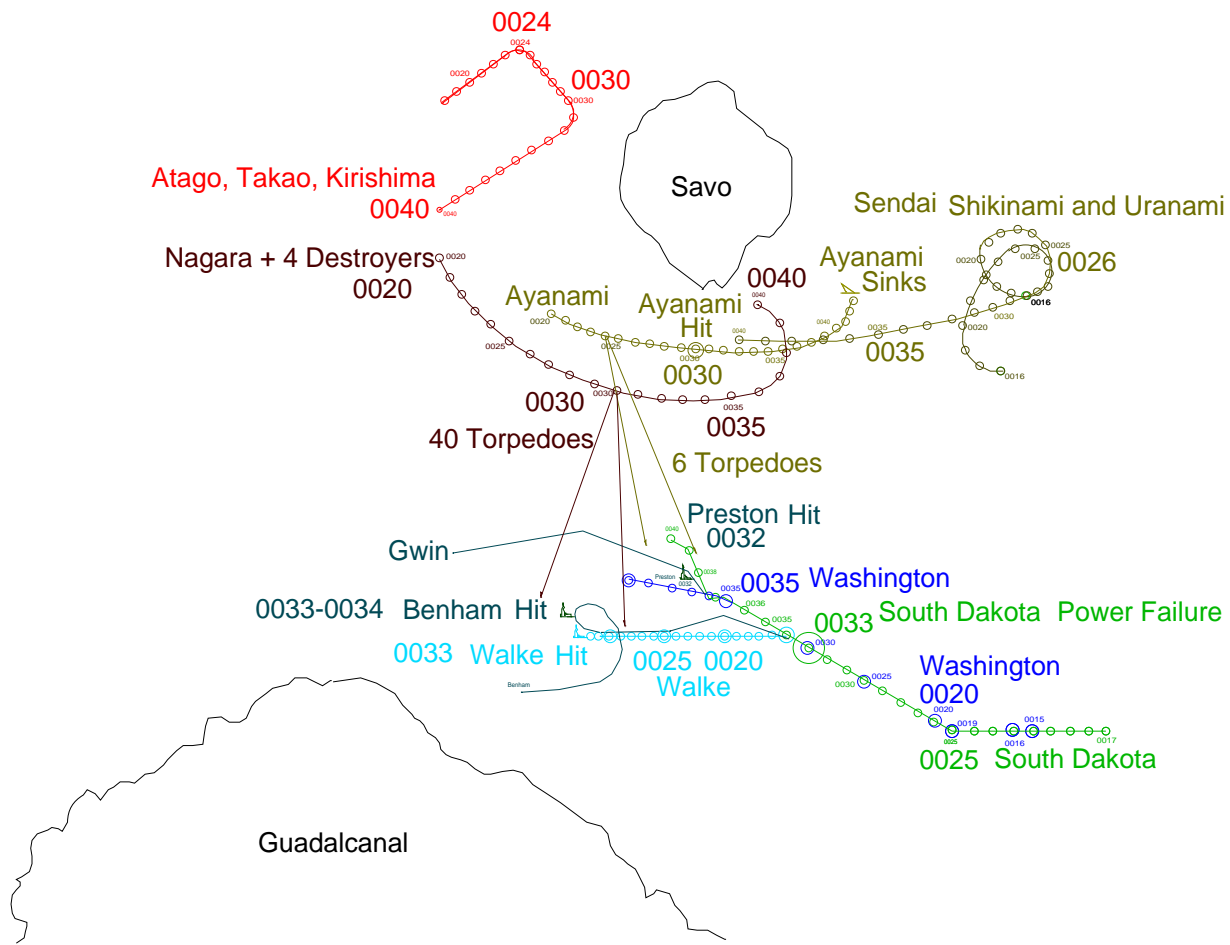
Destroyer Action from 0020 to 0040
Figure 2

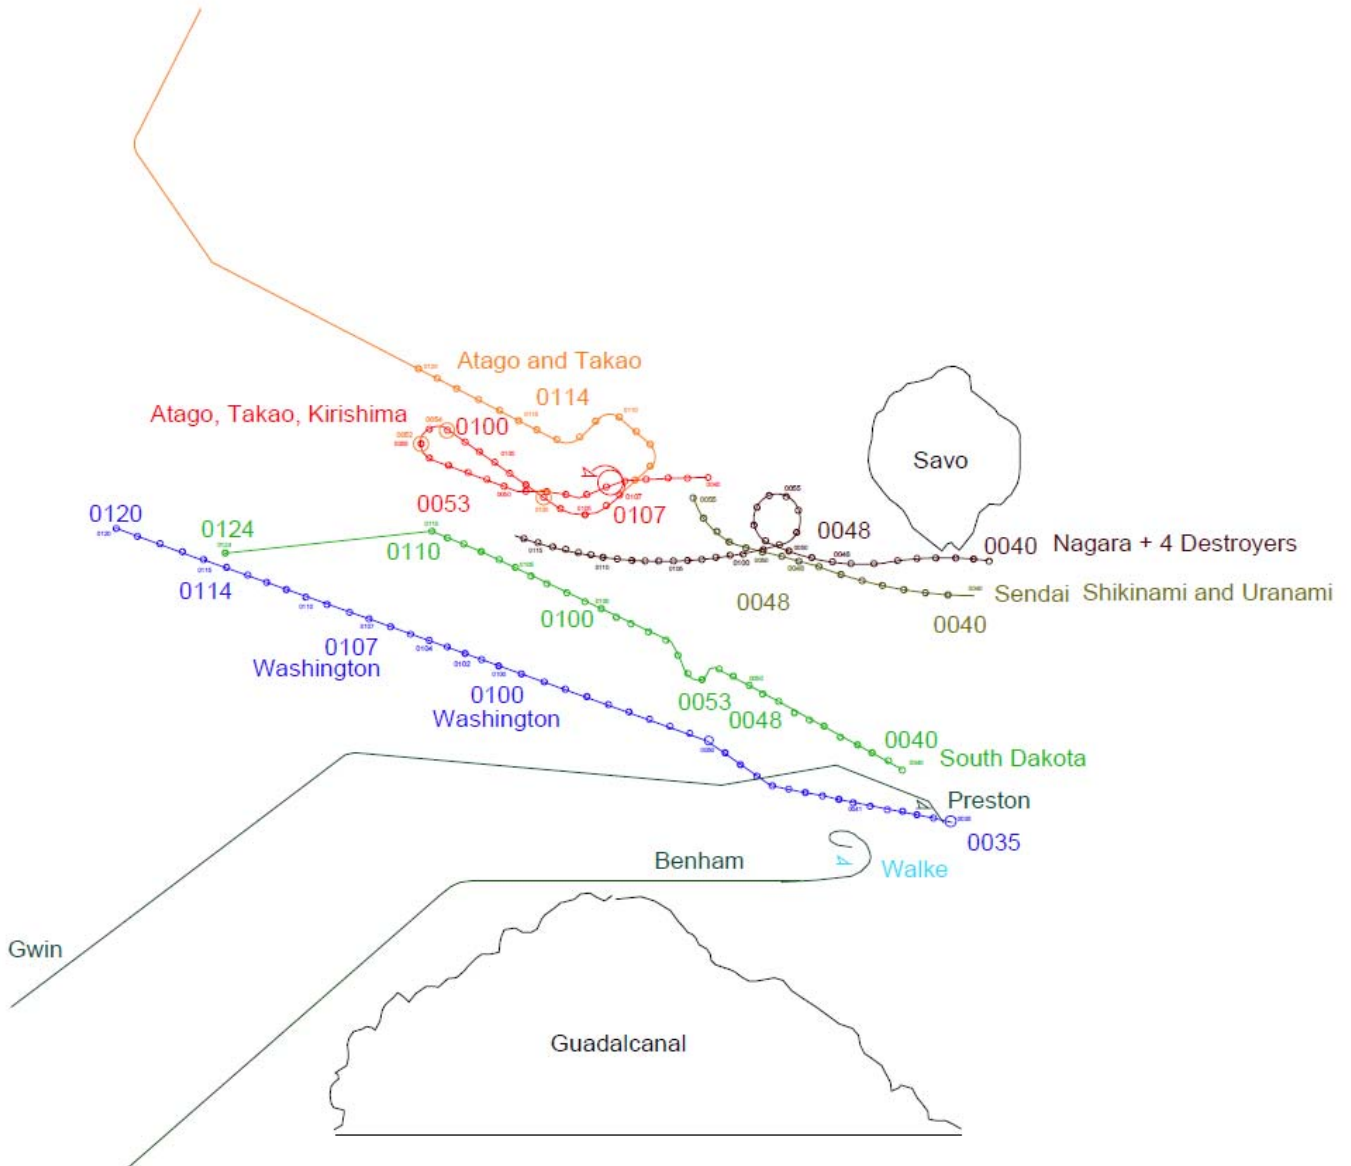
**The Battleship Action from 0040 to 0114
Figure 3**

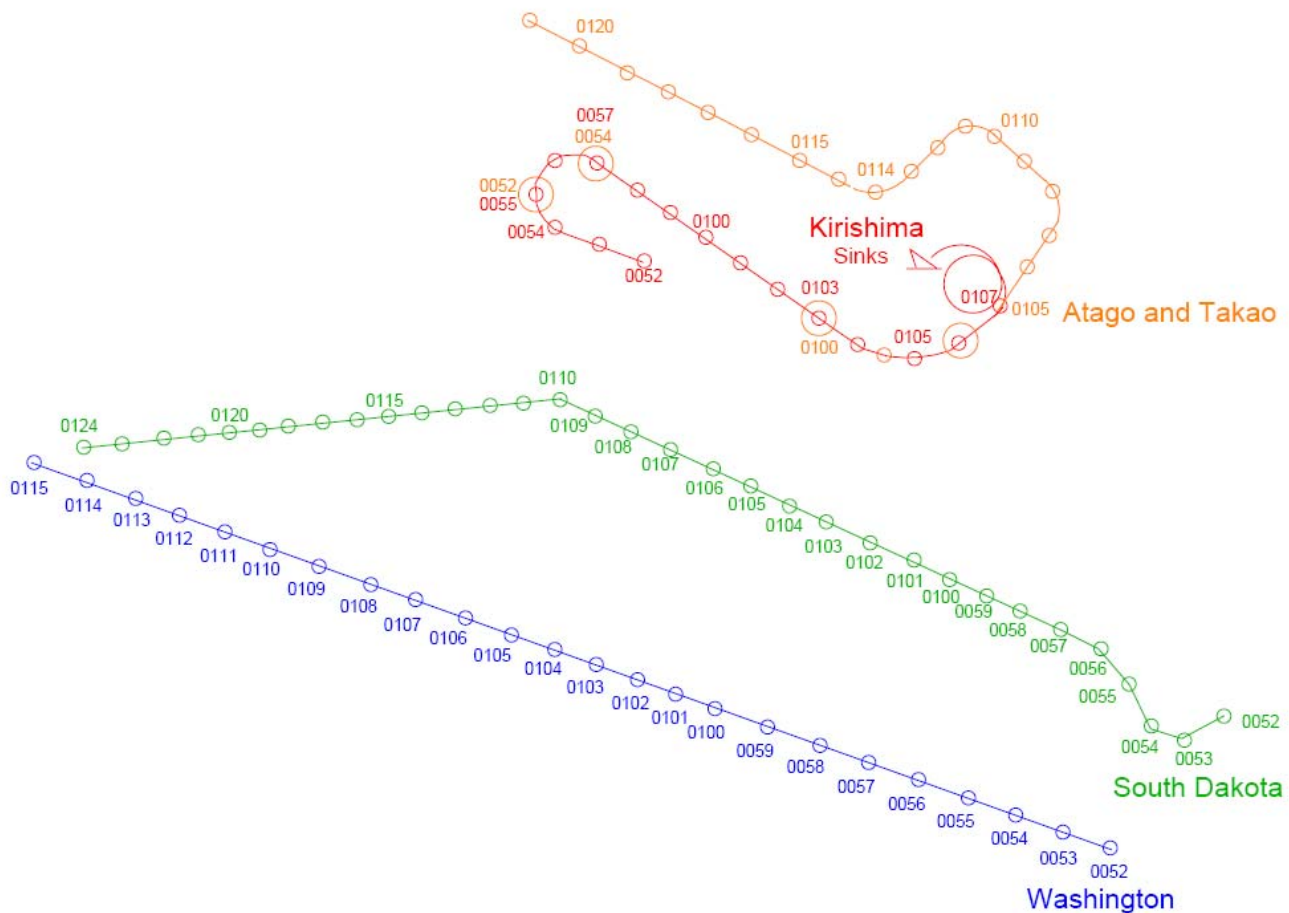
The Battleship Action from 0050 to 0114
Figure 4

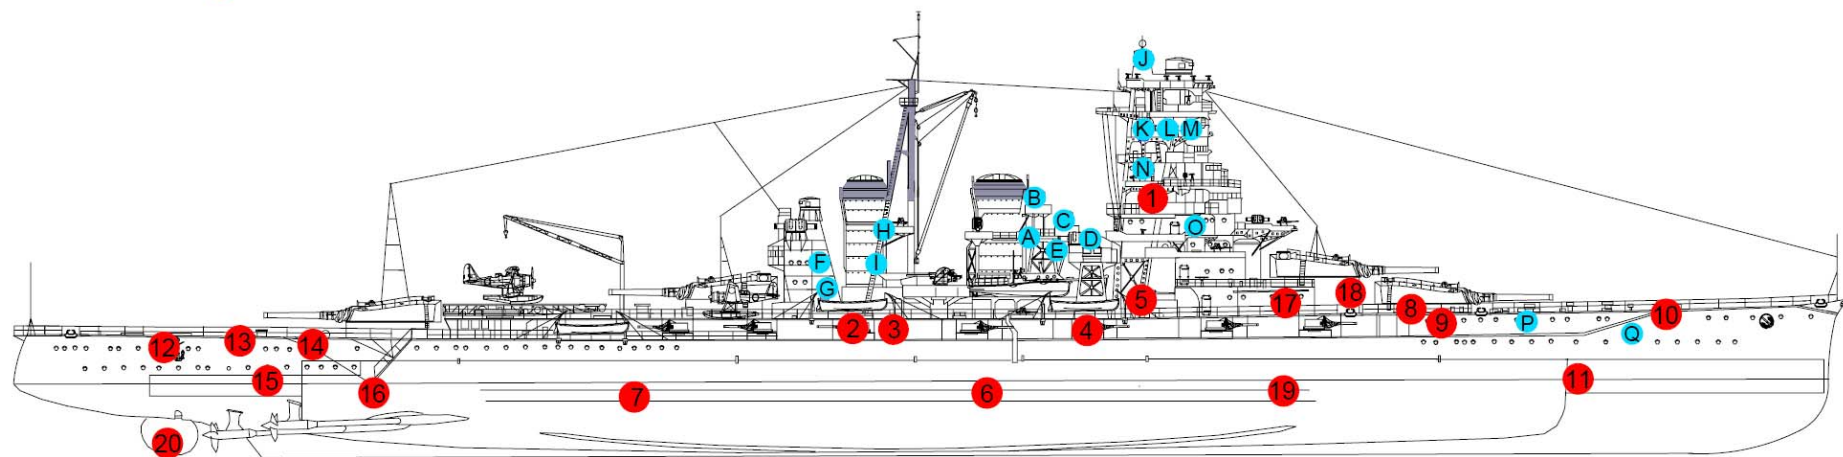
Kirishima November 1942

- 16-inch shell hits
- 5-inch shell hits

***Kirishima's* hit locations**
16-inch shell hits in red and 5-inch shell hits in blue
Figure 5

According to Ikeda the chief damage control officer Lt.Cdr. Hayashi told him that *Kirishima* had received fourteen major caliber hits above the waterline and 17 medium caliber hits as well as six underwater hits all rated as major caliber. According to Ikeda, *Kirishima* fired 68 Type 3 [incendiary], 22 Type 0 [HE], and 27 Type 1 [AP] 14-inch shells at the enemy battleship. Lookouts reported ten 14-inch shell hits on *South Dakota*. The Damage Control Officer Hayashi prepared a hit scheme in which Ikeda meticulously copied.
